## Chapter 9

# FIRE BEHAVIOR IN WORLD TRADE CENTER 2

### 9.1 INTRODUCTION

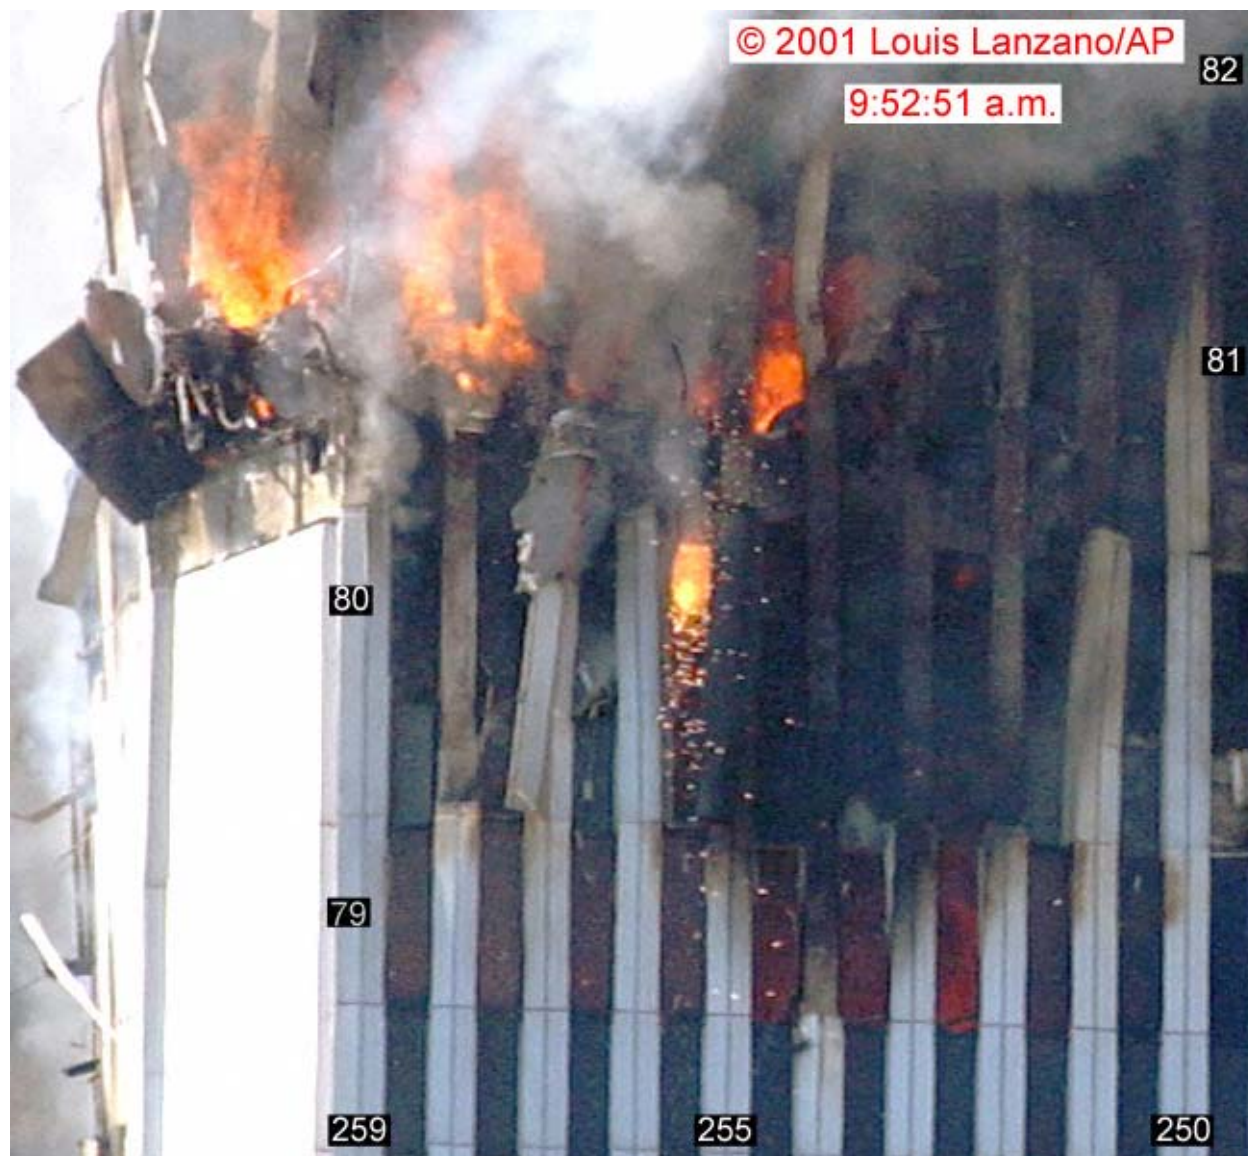
First, consider Figure 9–72. Videos show that a small amount of molten material poured from window 80-255 within a second or two after this photograph was taken. In the photograph the bright material is visible inside this window at the top. The area seems to be surrounded by a large number of glowing drops, which are likely associated with the liquid that will pour out shortly. Dull, deep-red glowing areas are just visible at the tops of windows 80-252 and 80-254. These might be an indication that the 81st floor slab has sunken below the spandrel at the base of this floor.

**Figure 9-72. This image is a blow-up of a portion of Figure 9-71 showing the north face of WTC 2 around window 80-255 at 9:52:51 a.m. Column and floor numbers have been added.**

This image provides a good view of the fire that continues to burn in the northeast corner on the 81st floor. It can be seen that column 81-254 on this floor is severely distorted. This damage may be a result of the landing gear that was identified as passing through the area during the aircraft impact (see the discussion in Section 7.4.3). Flames are also visible on the 79th floor through open windows 79-252 to 79-254. The orange color visible through the glass that remains in place in window 79-251 and windows 79-255 to 79-258 shows that fire is present behind these closed windows as well. This is one of a limited number of cases in which flames were seen through windows with glass still in place. In Figure 9-61, which was shot at 9:46:32 a.m., small flames could be seen in window 79-254. At this time the glass for window 79-252 was still intact.

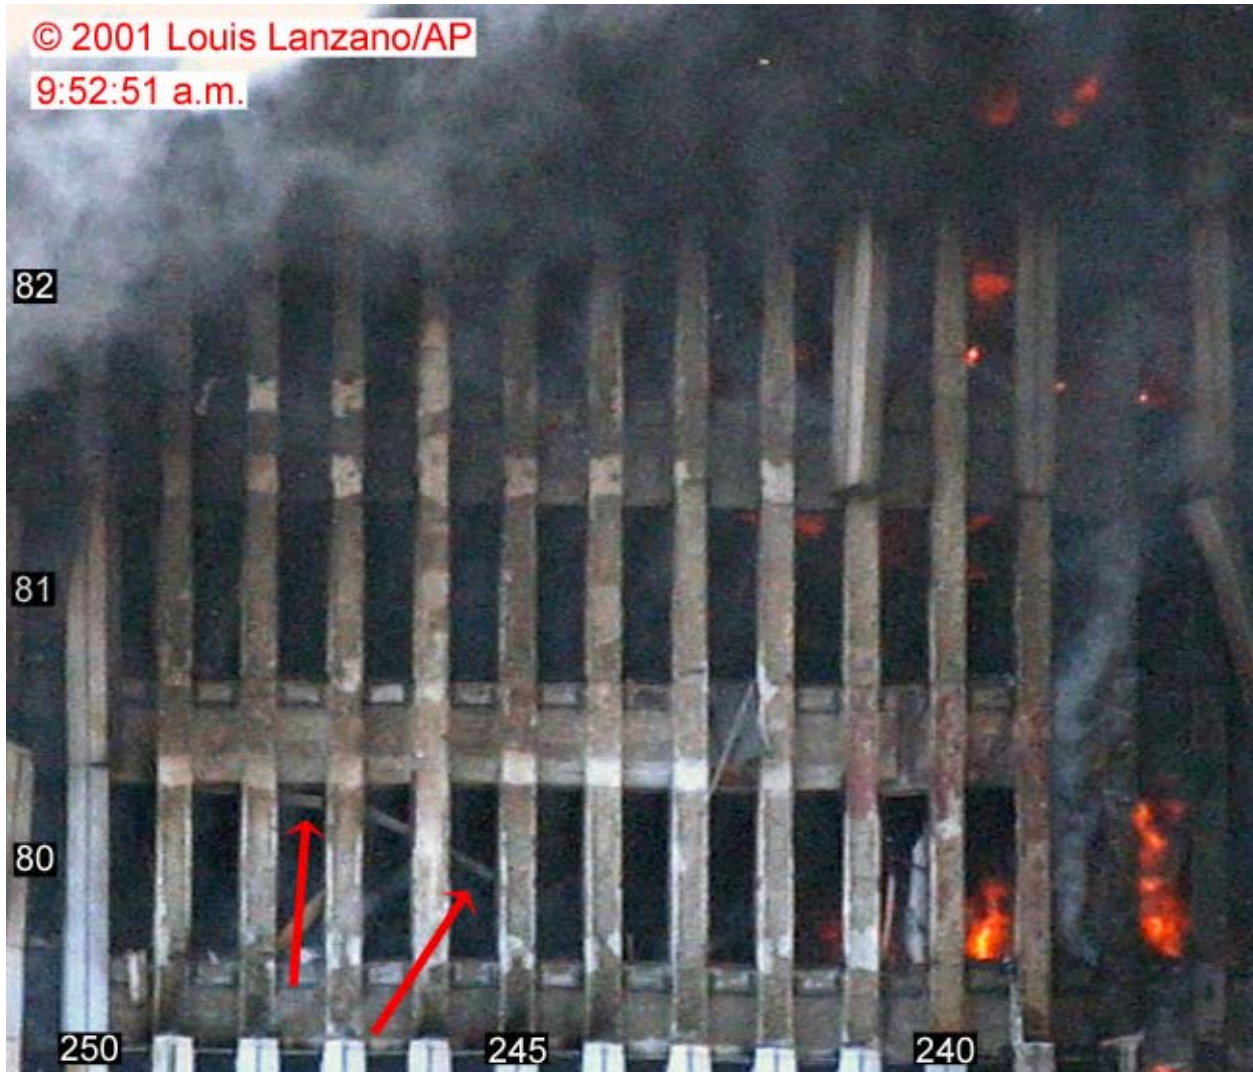
It is instructive to compare the image of the cold spot in Figure 9–73 with the close up shown in Figure 9–62, which was taken nearly 6 min and 20 s earlier. The first thing to note is that the hanging object on the 80th floor did not change position between 9:46:32 a.m. and 9:52:51 a.m. The fire burning on the west side of the cold spot on this floor has died down somewhat.

**Figure 9-73.** This image is a blowup of a portion of Figure 9–71 showing the cold spot on the north face of WTC 2 at 9:52:51 a.m. Column and floor numbers have been added. The arrows highlight a hanging object visible through open windows on the 80th floor.

The hanging object visible on the 81st floor at the earlier time is not apparent in Figure 9–73. This could simply be due to lighting, since the later photograph is somewhat darker, even though the intensities have been adjusted. In Figure 9–62 small flames were visible through window 81-243. In the later image these flames are not evident, but there is a curved region of dull red flames running from the top of window 81-242 to the middle of window 81-239. It is unclear why these flames are raised, i.e., what is holding them up in the window. One possibility is that the fuel for the fire is on top of a section of the 82nd floor slab (not visible) that became dislodged and settled below the spandrel at the base of the floor.

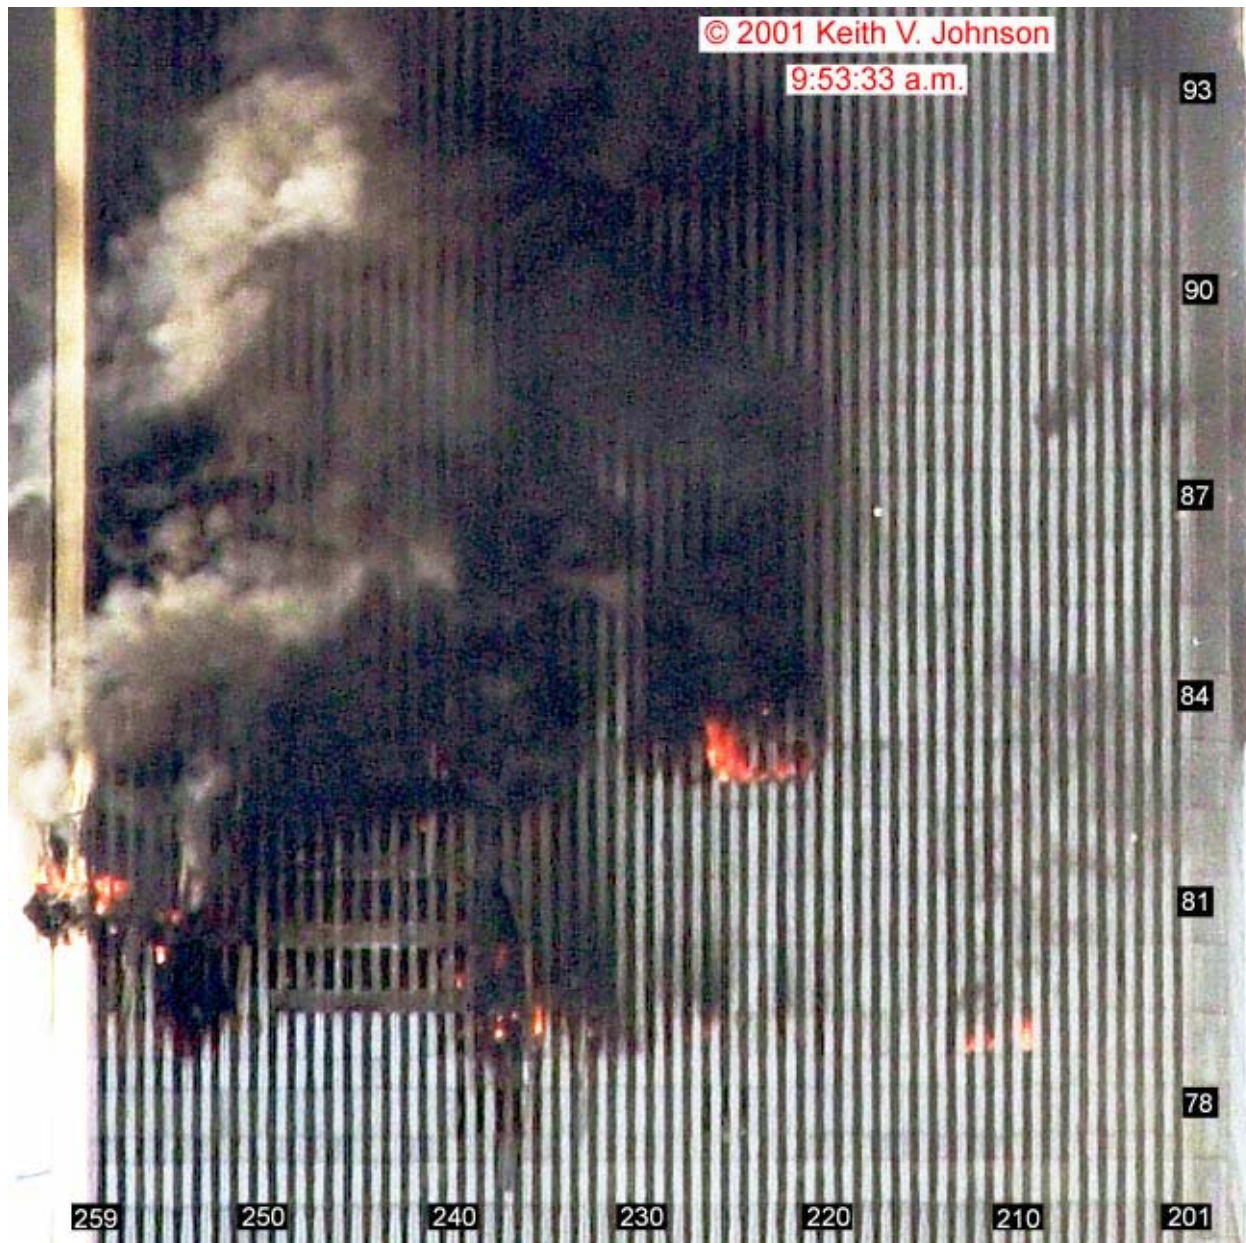
At 9:53:41 a.m. and 9:53:46 a.m. two pressure pulses forced additional smoke from windows on the north face. Both of these occurrences were accompanied by short flows of molten material from the same window, 80-255, on the 80th floor observed earlier. The largest flow occurred during the second release. Figure 9–75 shows a view of the northeast corner of WTC 2 taken from a video at 9:53:51 a.m. The bright molten stream flowing from the top of window 80-255 is prominent. Unlike earlier images (e.g., see Figure 9–71 and Figure 9–74, both of which were taken within a minute of 9:53:51 a.m.) showing this area of the tower, the intense fire burning on the 81st floor at the eastern edge of the north face has

substantially died down, and it is now possible to see clearly the 82nd and 83rd floors above for the first time. Videos suggest that the fire intensity at this location decreased around the time of the first pressure pulse at 9:53:41 a.m.

**Figure 9-74.** This cropped photograph shows the north face of WTC 2 at 9:53:33 a.m. The intensity range has been adjusted, and column and floor numbers have been added.

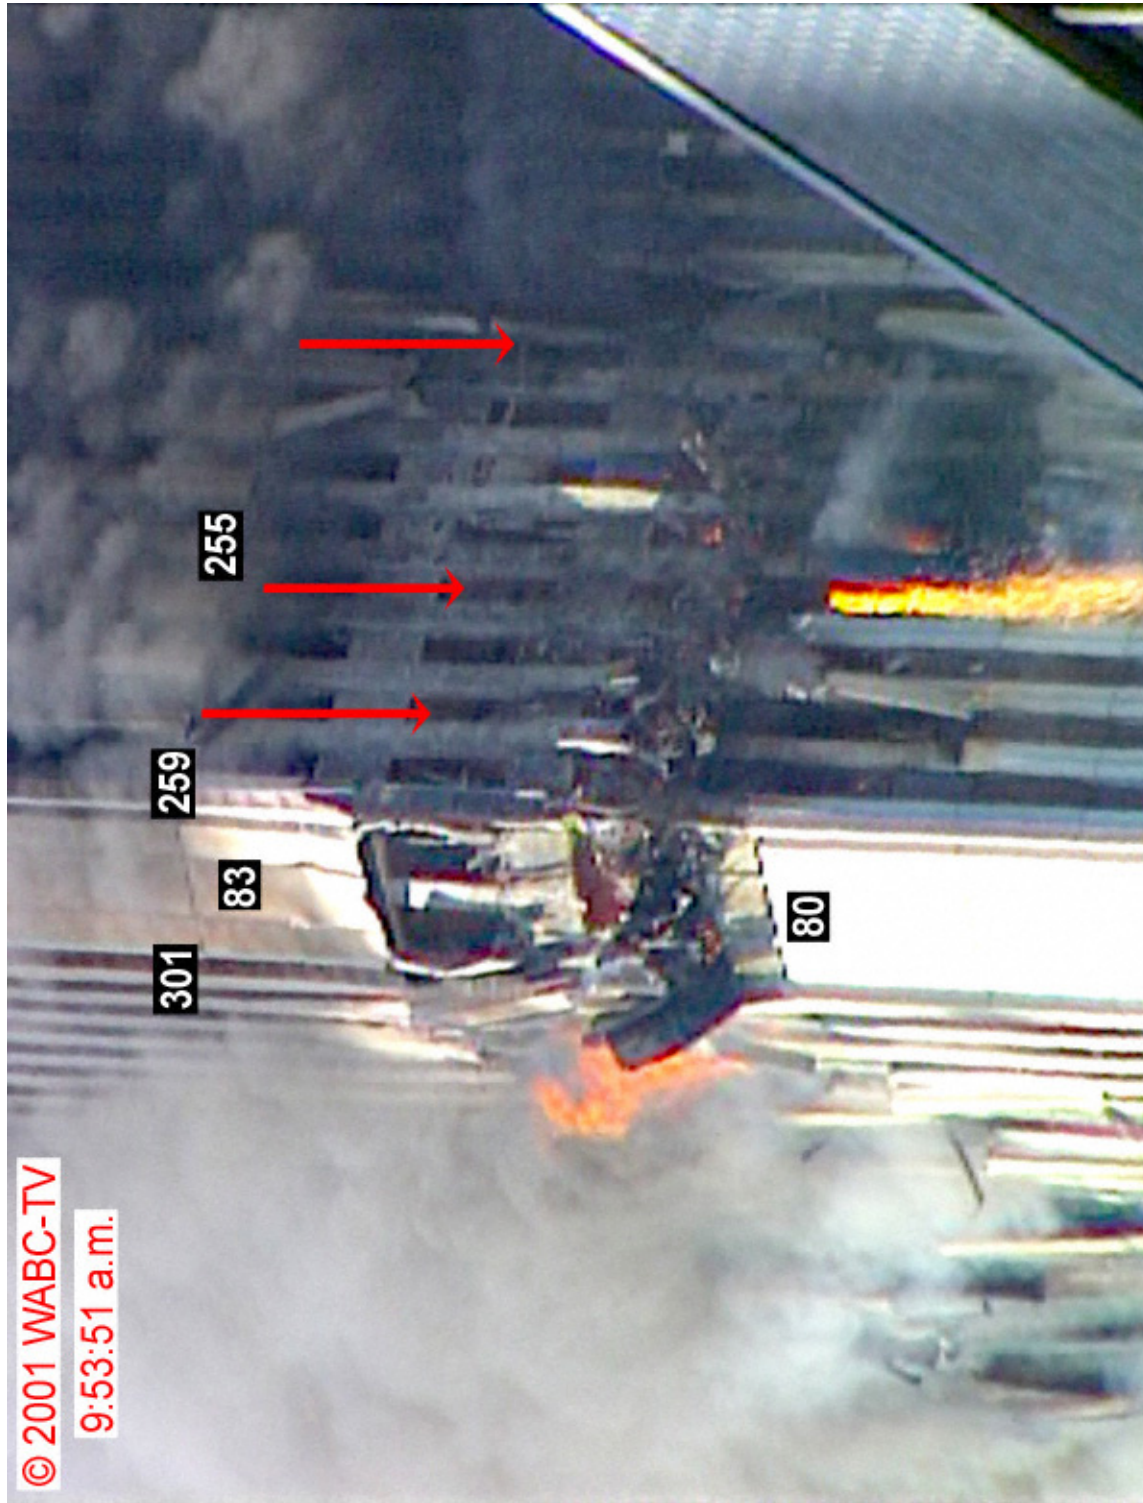
The arrows in Figure 9-75 highlight a hanging object that is visible through the open windows on the 82nd floor. In the windows nearest the east edge of the face, the object appears to have a flat surface that is being viewed from below and is drooping downward, away from the windows. The object also seems to be separated into two sections. Further to the west, the hanging object looks as if the edge of a flat object has dropped down below the top of the window from above. Its appearance is similar to the hanging objects seen elsewhere on the north and east faces of WTC 2.

Figure 9-75. This view of the northeast corner of WTC 2 is a frame captured from a video at 9:53:51 a.m. The intensity levels have been adjusted, and column and floor numbers have been added. The arrows highlight a hanging object that is visible through windows on the 82nd floor.

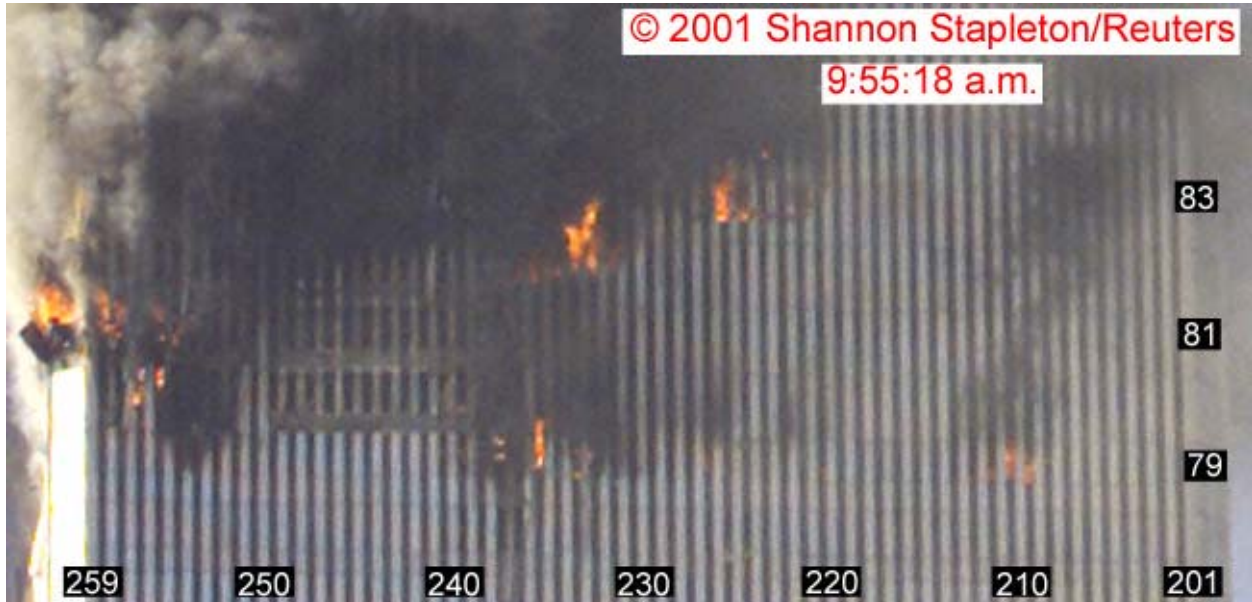
An image of the north face taken at 9:55:18 a.m. is shown in Figure 9-76. This image was shot 1 min 45 s after the one shown in Figure 9-74. The fire distributions are very similar in the two photographs, with the exception of the fire on the 82nd floor to the right of the cold spot in Figure 9-76. As discussed above, this fire was first observed at 9:53:47 a.m. burning in windows 82-234 to 82-337. At 9:55:18 a.m. flames were visible in windows 82-231 to 82-236, and flames were coming out of window 82-233. The bright spot at the top of window 80-255 is visible on the 80th floor, but there is no obvious molten liquid flow at this time. Unlike in the earlier photograph, fire is now visible in the adjacent window, 80-256.

**Figure 9-76. This cropped photograph shows the north face of WTC 2 at 9:55:18 a.m. The image has been rotated, and the intensity levels have been adjusted. Column and floor numbers have been added.**

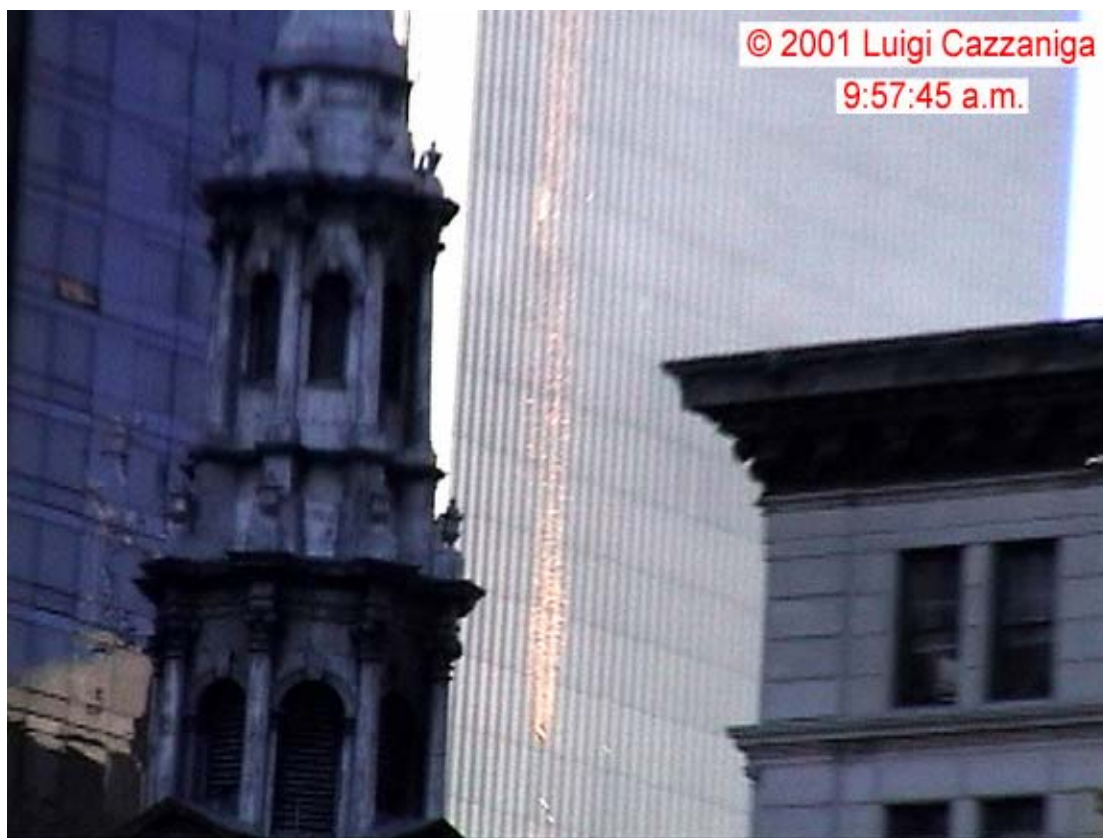
Figure 9–77 is a frame from a video that was shot at 9:57:45 a.m. It shows the falling molten metal as it was approaching the ground. The large amount of falling material is evident. Most of the molten metal seems to have broken up into small “droplets,” but there are a couple of large pieces falling as well. Apparently, the material flowing out of window 80-256 also included pieces of debris that had not fully melted. There was another very heavy flow of molten metal at 9:58:35 a.m.

**Figure 9-77. This frame showing the lower portion the north face of WTC 2 was captured from a video shot from the northeast at 9:57:45 a.m. The intensity levels have been adjusted.**

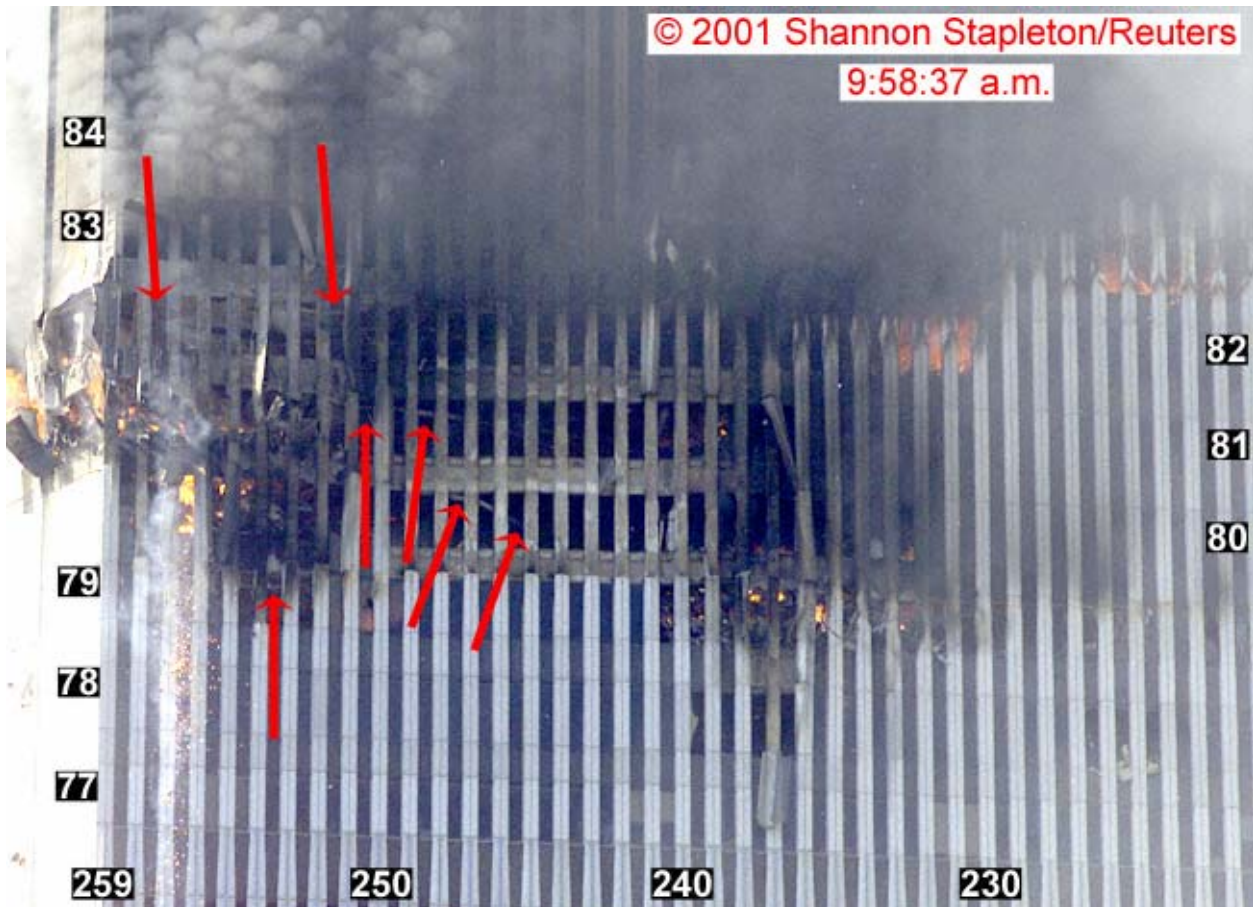
Figure 9–78 shows a photograph of the north face of WTC 2 taken at 9:58:37 a.m. The bright source of the recent molten metal flows stands out at the top of window 80-256 on the 80th floor. Some metal is visible flowing from the window at this time. An area, including this window and a portion of the cold spot, is blown up in Figure 9–79.

It is useful to compare Figure 9–78 with Figure 9–71, which was taken 5 min and 46 s earlier. Starting on the 83rd floor, it can be seen that the fire in windows 83-231 to 83-235 has died down considerably over the period between the photographs. In both cases the most intense flames are in window 83-225. Photographs and videos taken just prior to the collapse provide no indication of westward fire spread on this floor beyond window 83-220. The fire in this area grew rapidly just after 9:45 a.m. Apparently, it did not spread further after this time. The carets visible at the top of the adjacent columns show how intense the burning was in the area. The incipient fire on the floor above in window 84-223 is barely visible.

**Figure 9-78.** This cropped photograph shows the north face of WTC 2 at 9:58:37 a.m. The intensity levels have been adjusted, and column and floor numbers have been added. Arrows highlight hanging objects visible through open windows on the 79th, 80th, 81st, and 82nd floors.

The fire on the 82nd floor to the west of the cold spot, which grew rapidly just before 9:54 a.m., has continued to spread and grow. In Figure 9–71 there was no indication of this fire. At 9:58:37 a.m. flames are coming from windows 82-230 to 82-232. There are carets on the aluminum column covers around these windows, as well as on the covers next to windows 82-233 to 82-236. This fire seems to not only be spreading rapidly, but also to be going through a rapid cycle of growth and decline. Windows to the west of window 82-230 appear to have intact glass. No flames are visible in or to the east of the cold spot on this floor. At the earlier time the area was hidden by smoke.

During the period between when Figure 9–71 and Figure 9–78 were taken, the fires on the eastern edge and the northeast corner of the 81st floor have died down considerably. Prior to 9:53 a.m. intense fires had burned in these areas continuously following the aircraft impact. After this time it was observed that these fires suddenly died down and then reappeared several times. These cycles seemed to be associated with pressure pulses that pushed smoke and/or dust out of open windows on multiple floors of the north and east faces. This may be an indication that these fires died down due to changes in their local environment, e.g., a partial collapse of a floor, as opposed to simply burning out the available fuel. A low-level fire continued to burn at the western edge of the cold spot on the 81st floor. There had been no

The fires burning on the 79th and 80th floors between columns 230 and 241 have also died down. As a result, the large amount of debris piled up in windows 79-234 to 79-240 is more apparent than in earlier images. It is still not possible to identify whether the fires on these two floors were burning on a single pile of debris, i.e., the intervening floor had collapsed, or as two independent fires.

The only indication in Figure 9-78 of a fire burning on the 79th floor to the immediate west of window 79-229 is a small flame visible through a partially broken window 79-224. The fires that had been burning in this area earlier have nearly died out. Windows 79-221 and 79-223 to 79-225 still have glass. Half of the window pane is in place in window 79-222. These observations suggest that the fire that burned in this area was not too intense. Videos show that the fire that grew further west in windows 79-109 to 79-113 (see Figure 9-76) continued to burn at a comparable intensity until the tower collapsed. In Figure 9-78 it can be seen that window glass remains in place on the 80th floor in window 80-231 and windows to the west. Videos show occasional smoke coming from window 80-204 starting after 9:55 a.m. There is no indication of fire at this location. This window may have been broken earlier by a person.

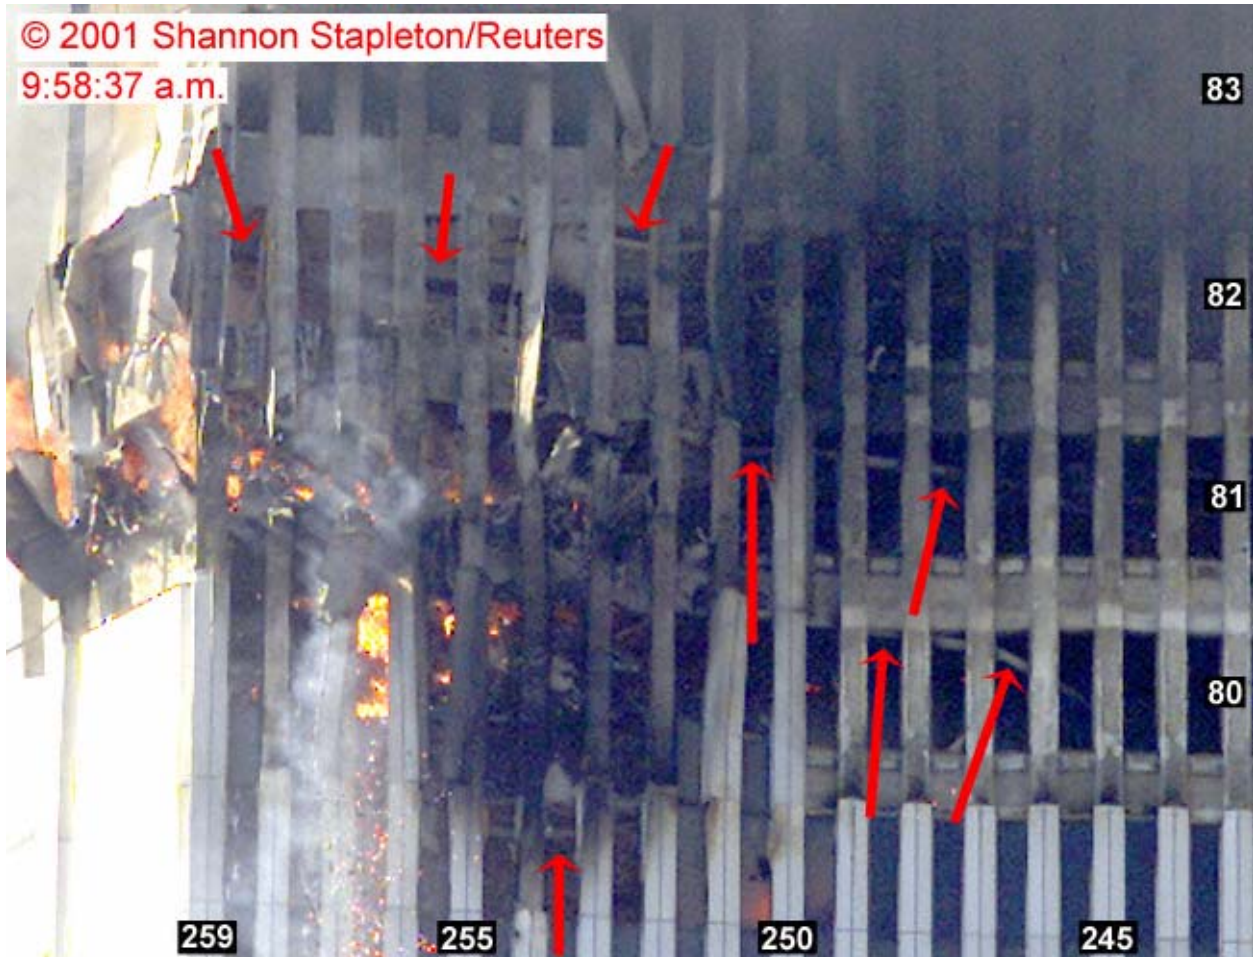
The blow-up of a section of Figure 9-78 shown in Figure 9-79 provides a closer view of the area around the 80th-floor window 80-256 and a portion of the cold spot. Since smoke is no longer obscuring the east side of the 81st floor, it is possible to see additional details concerning the damage in this area. The distortion of column 254 on the 81st floor, which was described earlier, is apparent. The column just to the west, 253, has been cut through near the top of the window. The spandrel at the base of the 82nd floor between column 251 and column 252 appears to be torn. It is not possible to say with certainty, but it is likely that this steel damage resulted from the large object observed exiting near this location during the aircraft impact (see the discussion in Section 7.4.3) and that it is not due to subsequent events.

A number of arrows have been added to Figure 9-79 to highlight hanging objects visible through open windows. These objects are possibly sections of floors slabs that became dislodged and settled down from above. The appearance of the object visible through windows 82-250 to 82-258 on the 82nd floor supports such a conclusion. This object was previously identified in a somewhat lower resolution image shown in Figure 9-75. Its appearance does not seem to have changed since 9:53:51 a.m. In windows 82-250 to 82-252 the object is hanging just above the tops of the windows. In these windows it looks like the hanging objects observed elsewhere on the north and east faces. However, further east it is apparent that a portion of the object located away from the edge has collapsed, and what is visible is the bottom of the object that is sloping away from the tops of the windows. It can be seen that the object has split into two sections in the east-west direction. This object is most likely a section of the 83rd floor that has locally collapsed and, in the process, broken along the line between two prefabricated sections. Drawings of the floor system indicate the sections were laid in this direction.

On the 81st floor a hanging object is apparent in Figure 9-79 at the tops of windows 81-247 to 81-250. A faint trace of the object in the two windows to the west indicates the object is sloping sharply downward in windows 81-246 and 81-245. This object was not visible in the close-up of the area shown in

Figure 9-73, which was taken at 9:52:51 a.m. This was true even when the intensity levels for the photograph in Figure 9-73 were adjusted to emphasize the darkest levels. Interestingly, a hanging object is visible in this same vicinity in Figure 9-62, which was taken at 9:46:32 a.m., but it was located further west and had a different shape. A detailed comparison shows that the objects in the two photographs are at roughly the same height in window 81-250, but while the object curved upwards in windows 81-249 and 81-248 and disappeared above the spandrel in window 81-247 in Figure 9-62, in the later image it slopes downward in windows 81-249 to 81-247. At the earlier time the object reappeared in window 81-245 and then sloped gradually downward toward the west. In Figure 9-79 the object nearly disappears in window 81-246 and seems to be curving strongly downward to the west.

**Figure 9-79.** This photograph is a blow-up of a portion of the photograph shown in Figure 9-78. It shows the north face of WTC 2 and includes window 80-256 and part of the cold spot. The intensity levels of the original have been adjusted, and column and floor numbers have been added. Arrows highlight hanging objects visible through open windows on the 79th, 80th, 81st, and 82nd floors.

It is difficult to understand why the object is not visible in Figure 9-73 at 9:52:51 a.m. Either it is hidden by some unanticipated optical effect or the object moved between 9:46:32 a.m. and 9:52:51 a.m. If the former is the case, it means that the object visible at 9:46:32 was obscured sometime between 9:46:32 a.m. and 9:58:37 a.m. On the other hand, if the latter is the case, it suggests that the object visible at 9:46:32 a.m. sank down out of sight between 9:46:32 a.m. and 9:52:51 a.m. and that a second object

In contrast to the 81st floor, the appearance of the hanging object visible through windows 80-245 to 80-248 on the 80th floor in Figure 9-79 is very similar to that seen in Figure 9-52 (taken at 9:42:31 a.m.), Figure 9-62, and Figure 9-73. Recall that this object appeared at this location sometime between 9:27:04 a.m. and 9:29:42 a.m. It has remained stable for around 30 min.

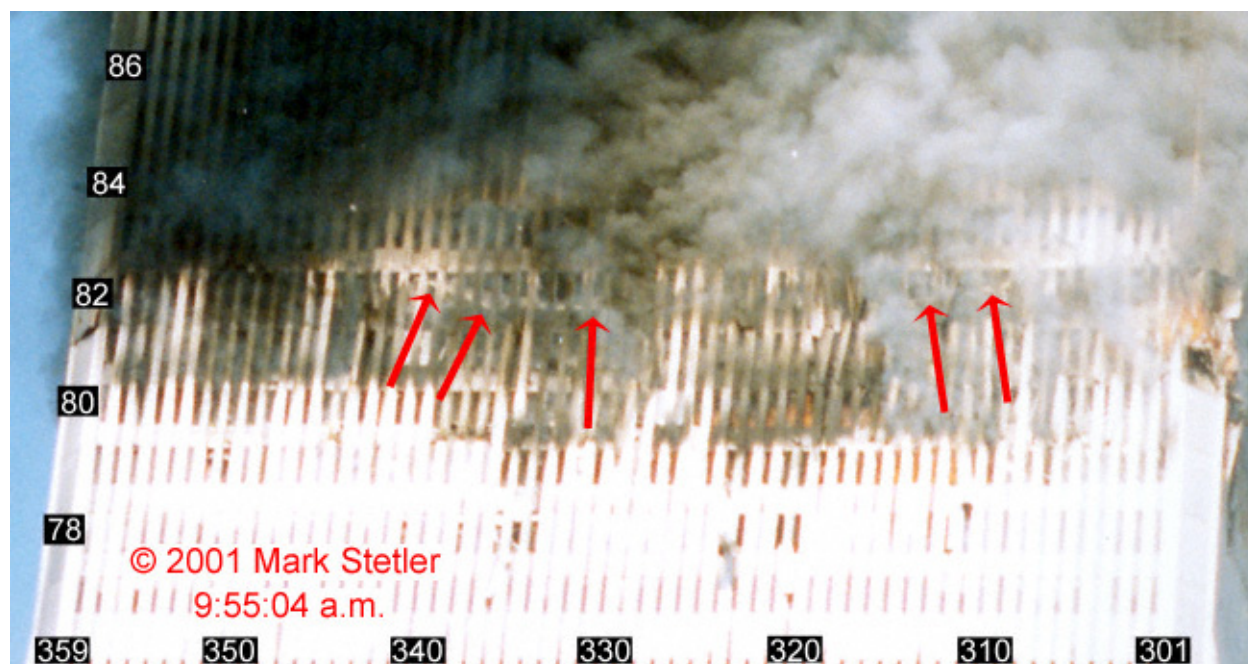
Figure 9–81 is a photograph of the east face that was taken at 9:55:04 a.m. This image was shot from a longer distance and from a higher position than Figure 9–80. In this image it is apparent that flames are present inside windows on the 79th floor over a length running from window 79-311 to window 79-319. This is roughly the same location as seen in Figure 9–67 at 9:47:10 a.m. Consistent with Figure 9–80, there is little smoke and no flame coming from the windows where fire is visible in Figure 9–81.

**Figure 9-81. This cropped photograph of the east face of WTC 2 was shot at 9:55:04 a.m. The image has been rotated, and the intensities have been adjusted. Column and floor numbers have been added. Arrows indicate a hanging object visible through open windows on the 82nd floor.**

There is also an area of flame visible on the 80th floor in Figure 9–81 extending from window 80-316 to window 80-326. Windows to the north of this length are hidden by smoke, while windows 80-327 and 80-328 on the other end still have glass in place. It is difficult to identify when this fire developed. These windows are visible in the east face view shown in Figure 9–48, which was taken at 9:38:22 a.m. At this time there was no indication of a significant fire in this area of the 80th floor, even though the fire on the 79th floor was already well developed. In similar views of the face shown in Figure 9–58 (9:40:29 a.m.), Figure 9–66 (9:45:40 a.m.), and Figure 9–67 (9:47:10 a.m.), smoke from the 79th floor hides these windows. Since the flames appear to be well inside and there is no smoke coming from the windows, it is not surprising that this fire can not be seen in Figure 9–80.

The arrows in Figure 9–81 highlight the hanging object visible through open windows on the 82nd floor. This object has been observed in a number of images, including Figure 9–67 at 9:47:10 a.m. On the southern end around window 82-340 the apparent position of the object has not changed during the almost seven minutes between the times when these photographs were taken. This is not the case at the northern end. At the earlier time the object was visible near the tops of windows 82-310 and 82-311. At 9:55:04 a.m. the object is visible at the top of window 82-309 and can be seen sloping downward across several open windows toward the left, approaching the base of window 82-315. This is another example of hanging objects, which may be dislocated floor slabs, changing position during the event.

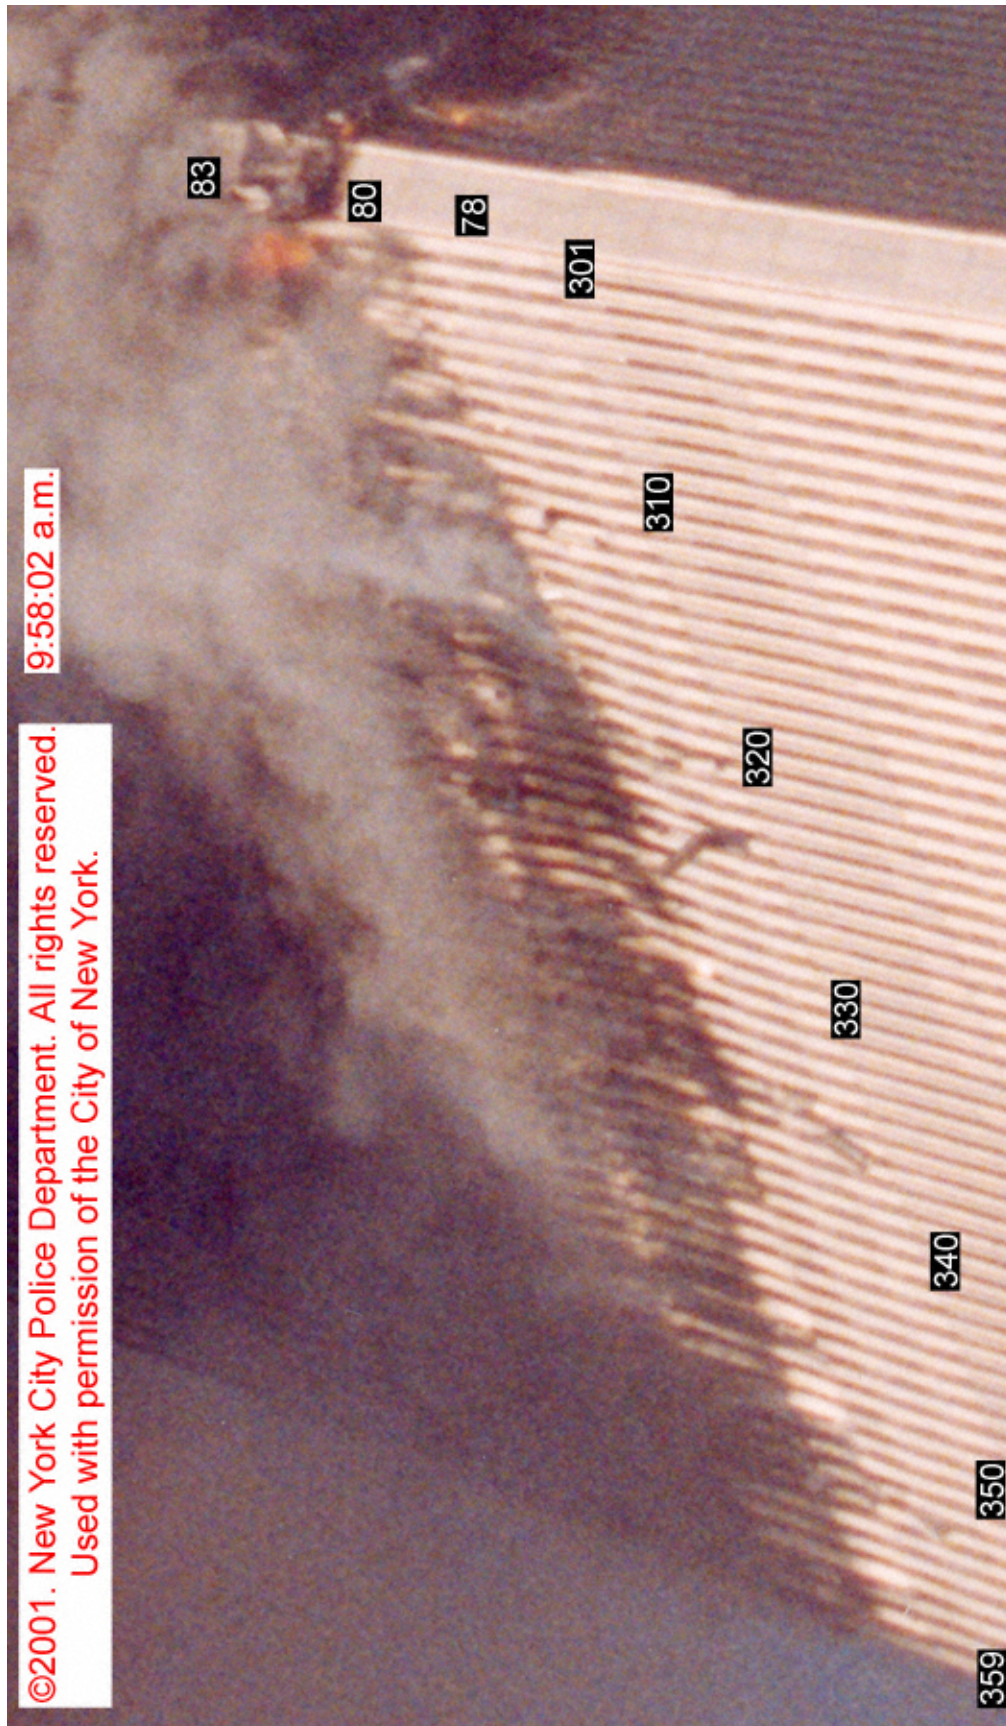
An even larger number of pieces of debris started falling from the same area around 9:58:49 a.m. This shower of debris lasted until the tower collapsed 10 s later. Figure 9–83 shows a photograph taken at 9:58:56 a.m., i.e., 3 s prior to the start of the collapse of WTC 2, from roughly the same location as Figure 9–82. A number of pieces of falling debris are visible on the north side of the east face.

The bowing of the columns near the center of the face stands out in Figure 9–83. Quantitative comparisons are difficult, but the bowing appears greater than in Figure 9–82. The fire visible at the northeast corner has a similar appearance to that seen earlier.

Figure 9-82. This cropped image shows the east face of WTC 2 at 9:58:02 a.m. The intensity levels have been adjusted, and column and floor numbers have been added.

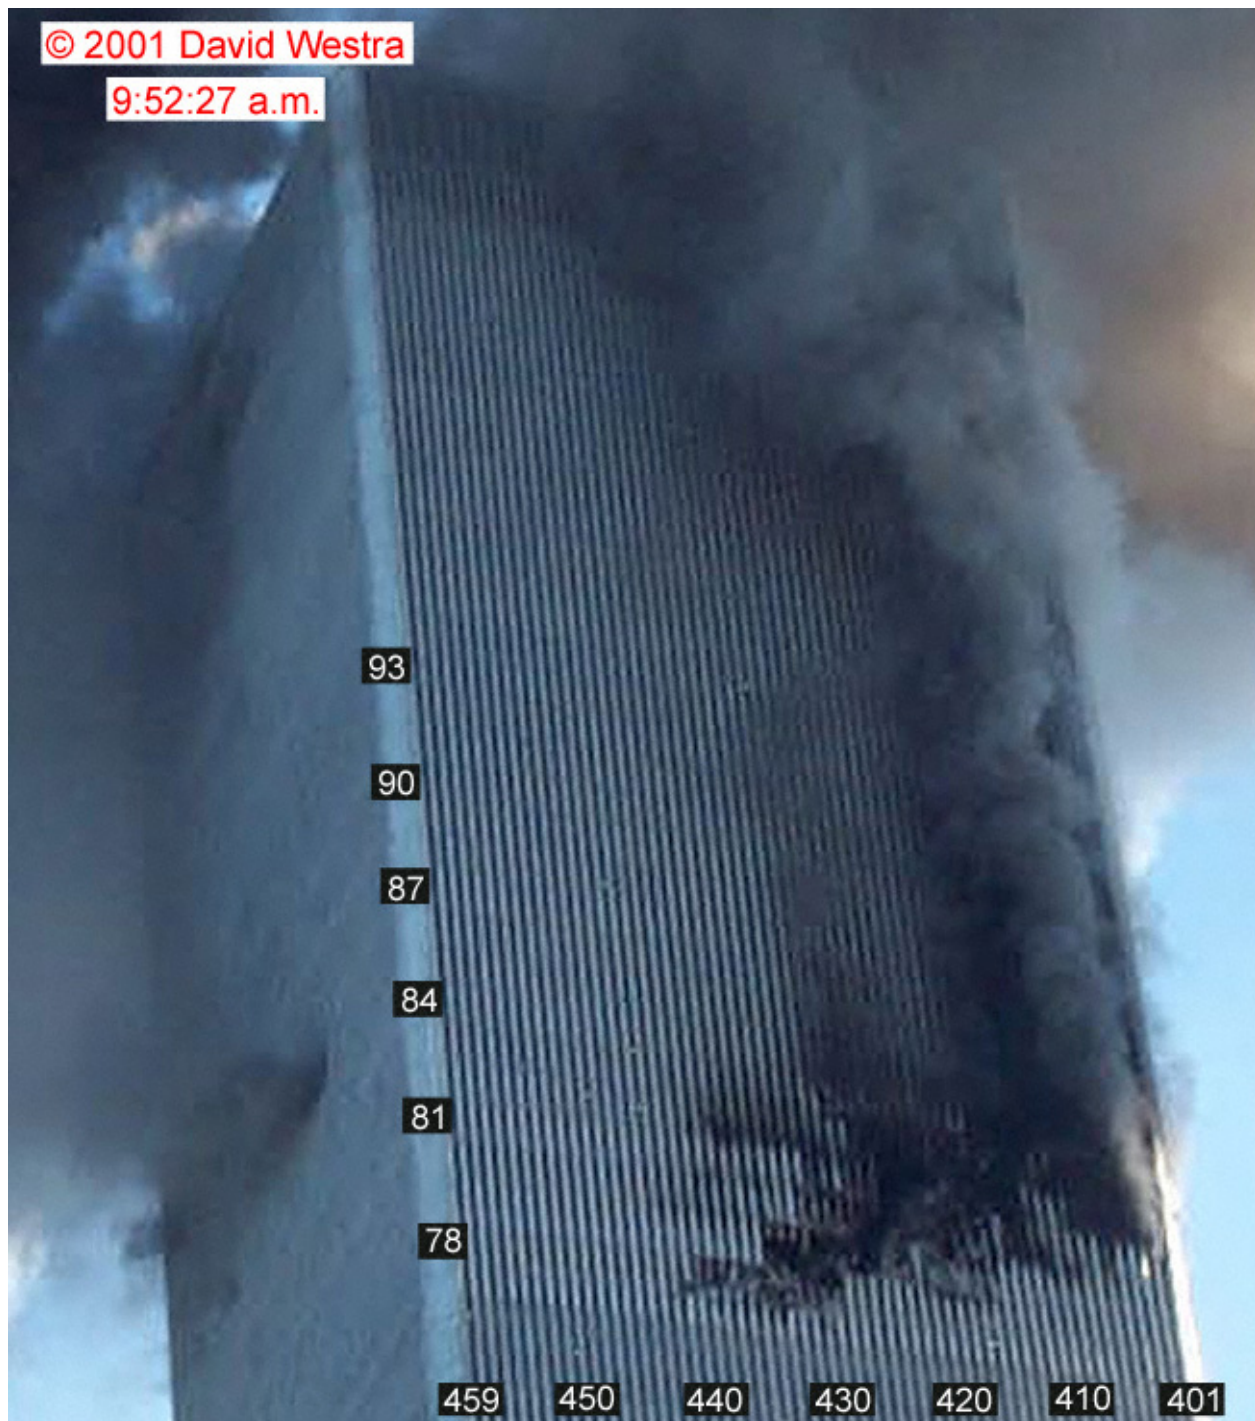
**Figure 9-84.** This cropped photograph shows the south and west faces of WTC 2 at 9:52:27 a.m. The intensity levels have been adjusted, and floor numbers have been added.

Views of the west face of WTC 2 at 9:52:27 a.m. and 9:57:49 a.m. are provided in Figure 9–84 and Figure 9–86, respectively. Smoke is coming from many of the open windows previously identified earlier as possibly having been broken by people. There are no indications of additional windows having opened, and no flames are visible. The visual evidence indicates that fires capable of breaking out window glass had not reached the west face of WTC 2 prior to the collapse.

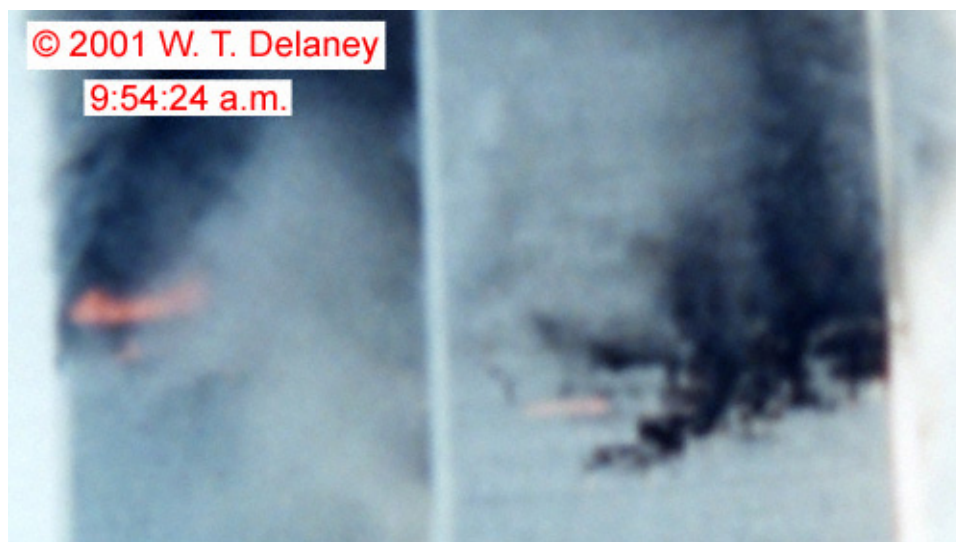
The video shot from the news helicopter shows that over the next few minutes the line of fire on the 80th floor had a steady appearance similar to that in Figure 9–85. Smoke flow from the fire area was generally light, even though there were occasionally streams of smoke released from various windows along the observed fire length. This situation changed at 9:56:44 a.m., when a heavy release of smoke lasting over 20 s took place from windows along the entire length of the fire. At this time the smoke appeared to be coming from as far west as window 80-454. Within 5 s of the start of the heavy smoke flow, large flames erupted from several windows centered near window 80-442. There was also a short flame flare from near window 80-450.

**Figure 9-85. This cropped image shows the south faces of WTC 1 and WTC 2 at 9:54:24 a.m. The intensity levels have been adjusted.**

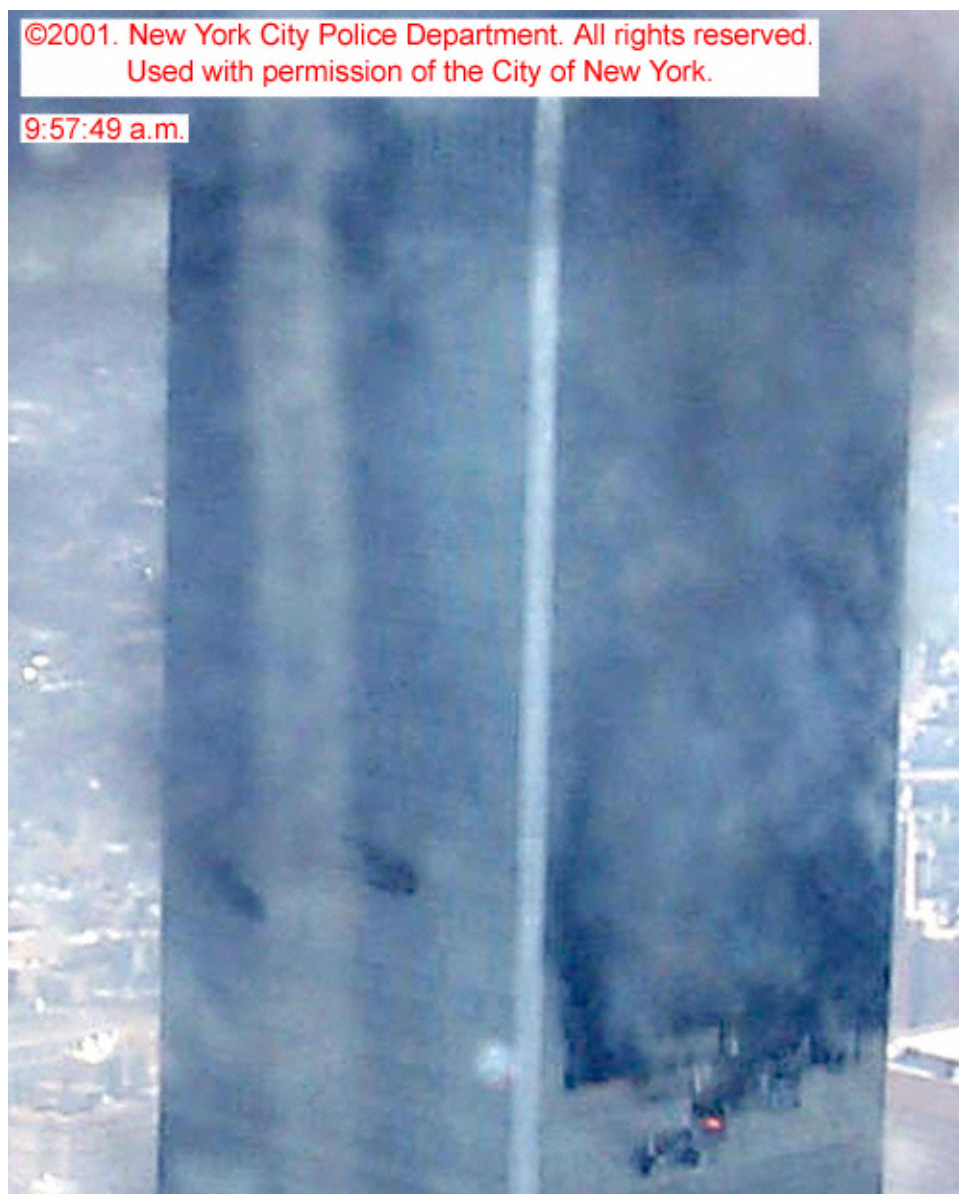
By 9:57:49 a.m. the smoke and flames on the 80th floor of the south face had subsided somewhat. The view of the south and west faces of WTC 2 at 9:57:49 a.m. shown in Figure 9–86 was taken from a NYPD helicopter looking down on the tower from the southwest. The line of smoke and flame to the west of the aircraft impact cavity on the south face is visible extending nearly to the west edge. Heavy smoke also appears to be coming from the 81st floor. There is a bright flame region visible near the 79th floor inside the aircraft impact cavity. Flames were observed in this general vicinity in several ground-based images including those in Figure 9–26 (9:23:08 a.m.) and Figure 9–41 (9:30:19 a.m.), even though such a large fire was not evident.

**Figure 9-86.** This cropped photograph showing the west and south faces of WTC 2 was shot from a helicopter at 9:57:49 a.m. The intensity levels have been adjusted.
